AFRL-ML-WP-TR-2000-4153

**HYDROGEN EMBRITTLEMENT OF
METAL FASTENERS DUE TO
PHOSPHORIC ACID CONTAINMENT
SYSTEM (PACS) EXPOSURE
VOLUME 5 - DELIVERY ORDER 4, TASK 2**

FINAL REPORT FOR PERIOD OF 13 SEPTEMBER 1996 – 30 SEPTEMBER 1997

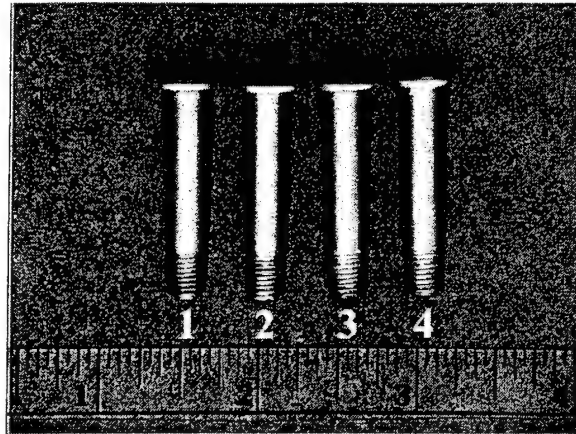
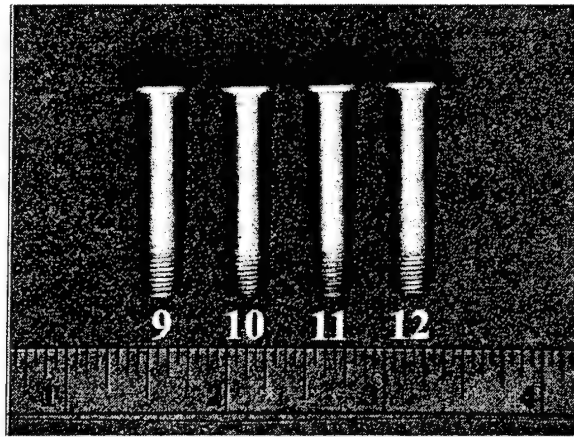
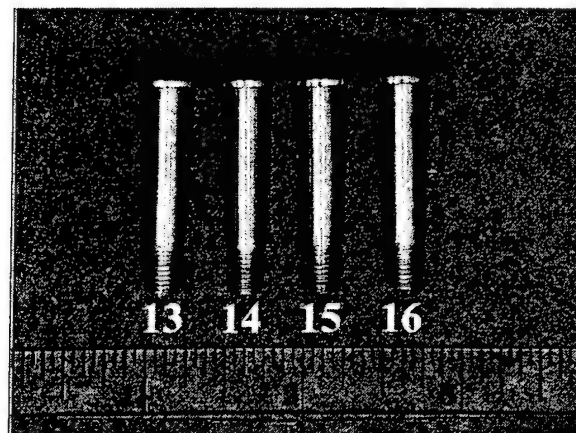
HL12 As-Received No PACS Exposure

HL12 As-Received PACS Exposure

HL12 Stripped PACS Exposure

Figure 5. Overall Photos of the Tested HL12 Fasteners. No failures occurred at any of the test conditions.

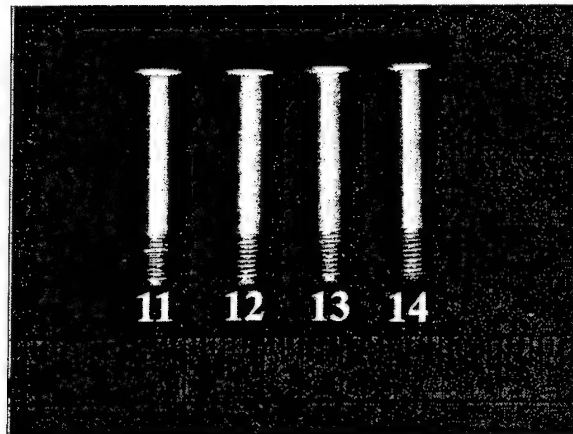
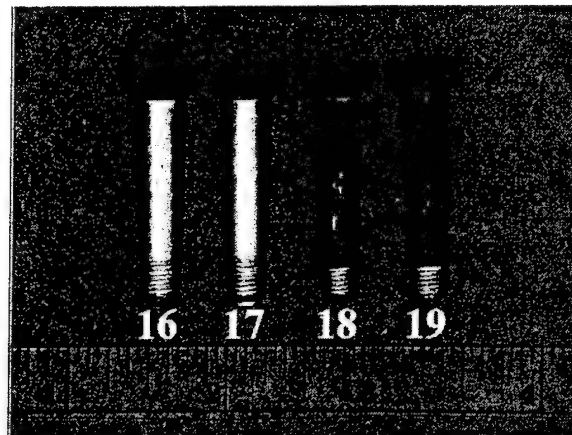
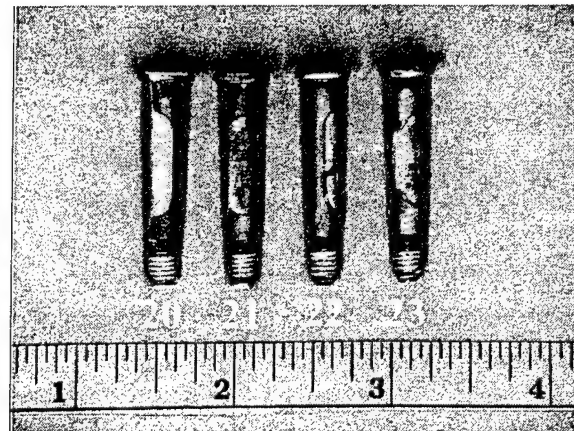
HL20 As-Received No PACS Exposure

HL20 As-Received PACS Exposure

HL20 Stripped PACS Exposure

Figure 7. Overall Photos of the Tested HL20 Fasteners. No failure occurred at any of the test conditions.

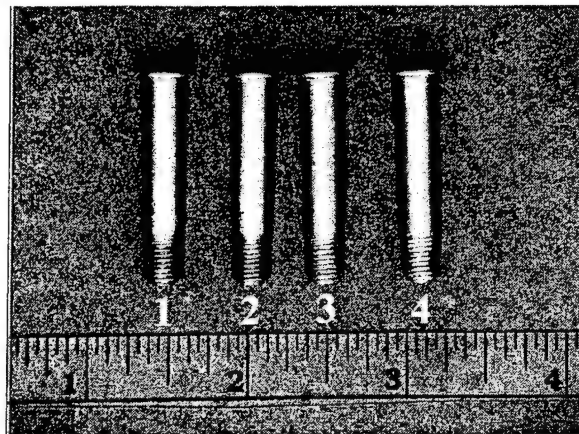
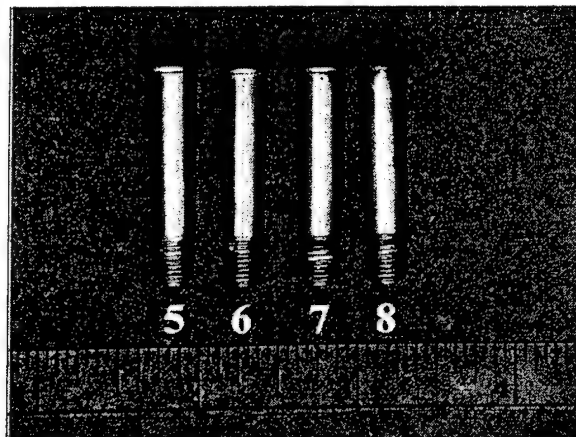
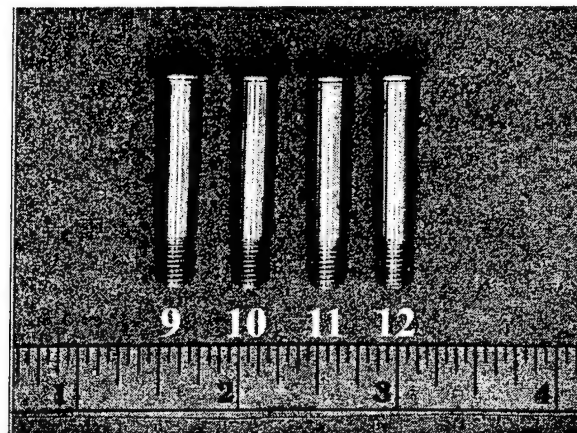
HL40 As-Received No PACS Exposure

HL40 As-Received PACS Exposure

HL40 Stripped PACS Exposure

Figure 9. Overall Photos of the Tested HL40 Fasteners. No failures occurred in any of the test conditions.
